10.5 Drive Roll Removal/Replacement

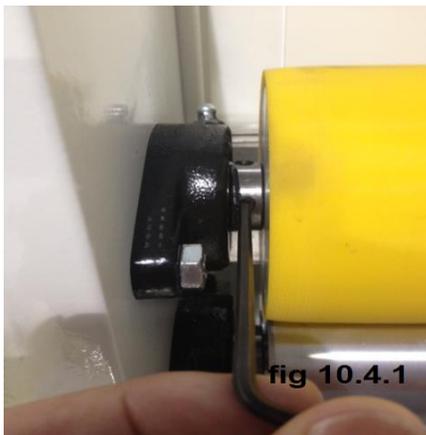
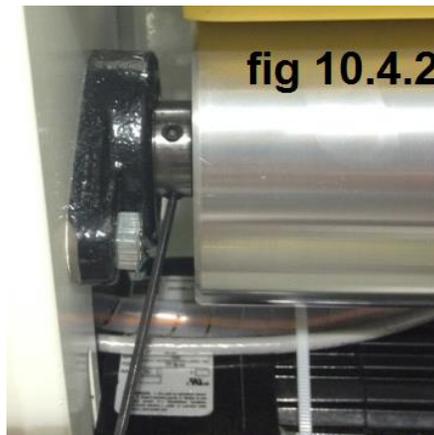
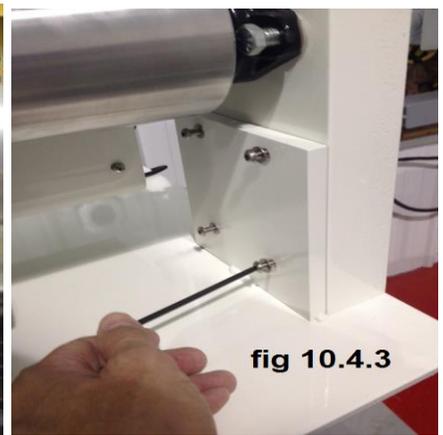
5. Remove the drive pulley from the drive roll as described in section 10.2
6. Using a 1/8” Allen wrench, loosen the two Allen screws from the inner bearings. (see fig 10.4.2)

7. Carefully slide the Drive Roll from the inner bearing assembly. Note the drive pulley was mounted to the long side of the Drive Roll shaft.
8. Reverse this procedure to re-install the Drive Roll.

2. Remove the Idler Roll as described in section 10.4
3. Open the door to the SSIU panel.
4. Using a 9/16” socket wrench, remove the four nuts securing the sub-panel within the SSIU. Once the four nuts have been removed, pull the sub-panel from the four threaded studs and swing the sub-panel away from the drive side of the SSIU.
